# RESULTS OF ROT'S MECHANICAL CONSTRUCTIONS INSPECTION

Herouni United Space Center

After the long stop of the Antenna of the ROT-54/2.6 it was necessary to collect and analyze data about possible metal fatigue of the mechanical construction of tripod and the pendulum carrying the secondary mirror.

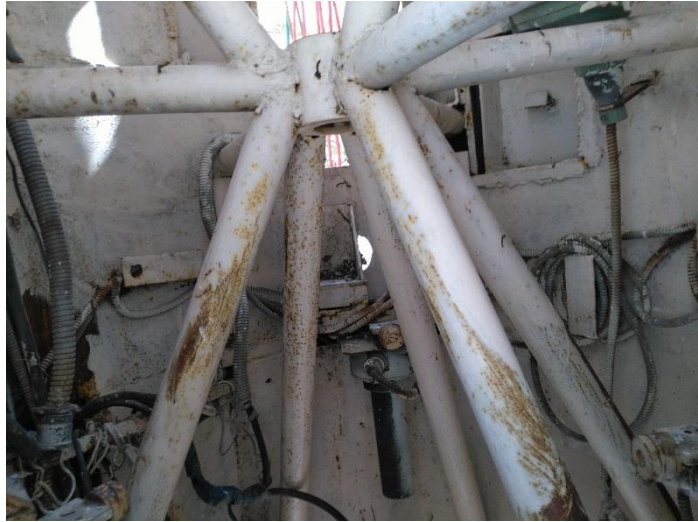
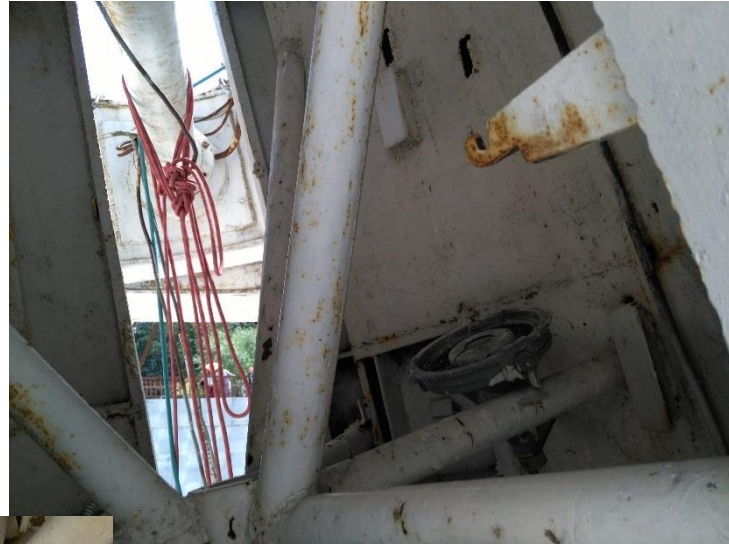
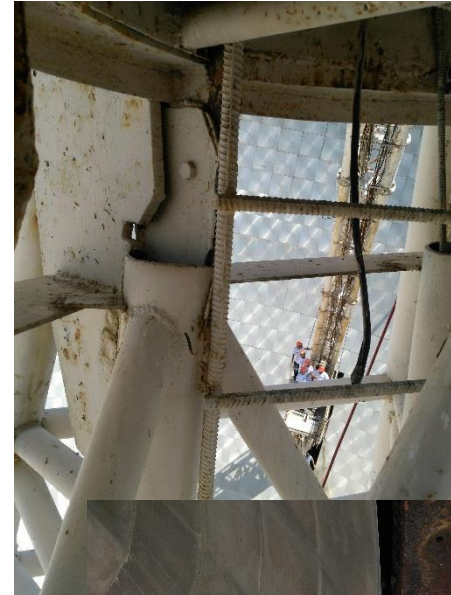
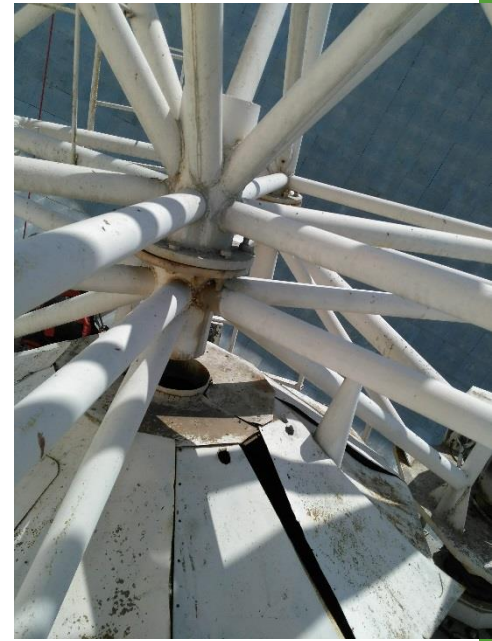
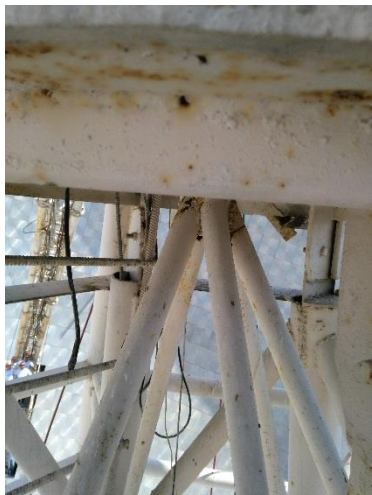
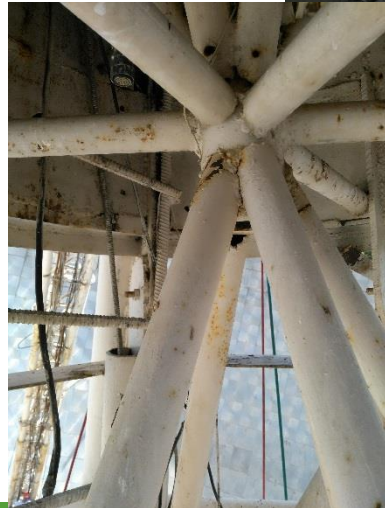
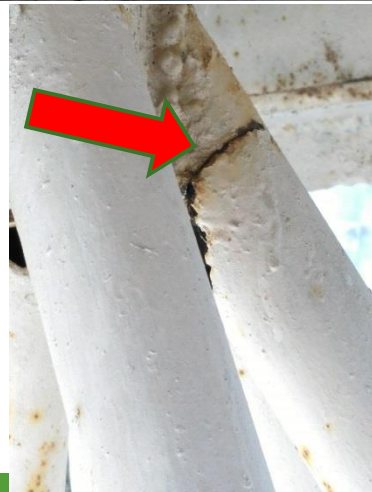
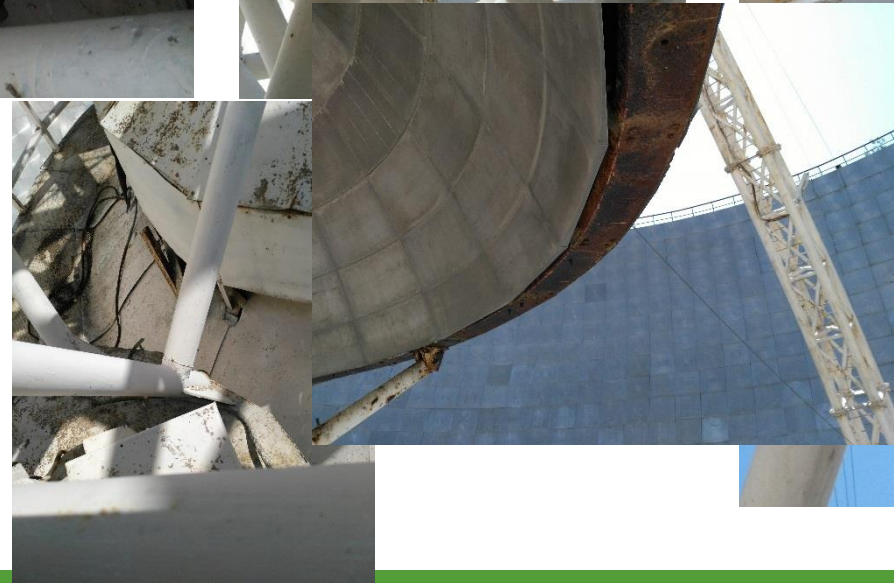
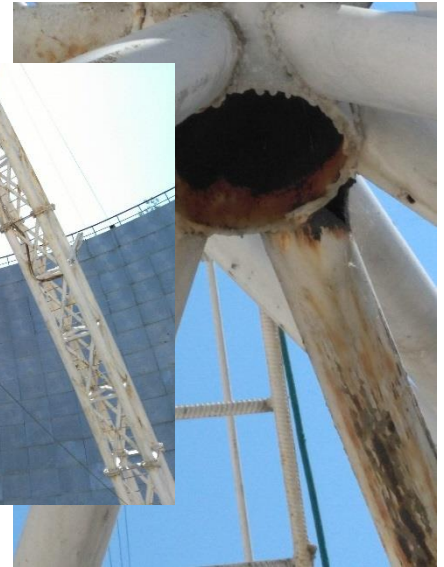
# Bottom part of the pendulum

- 1-2 fastenering cross-ferm places of the bottom part of the pendulum needs to be welded for repairing.
- Rust on many parts.
- In order to avoid farther corrosion it is necessary to paint constructions.
- No any serious risk for exploatation of the Antenna now.
